INCIDENT INVESTIGATION REPORT into A NEAR MISS BETWEEN A GRADER AND WORK GROUP ON THE COASTAL BYPASS CONSTRUCTION PROJECT

Prepared by
Safety Wise Solutions Pty Ltd

SWS 03 Ver 2 (Final) 30 July 2010

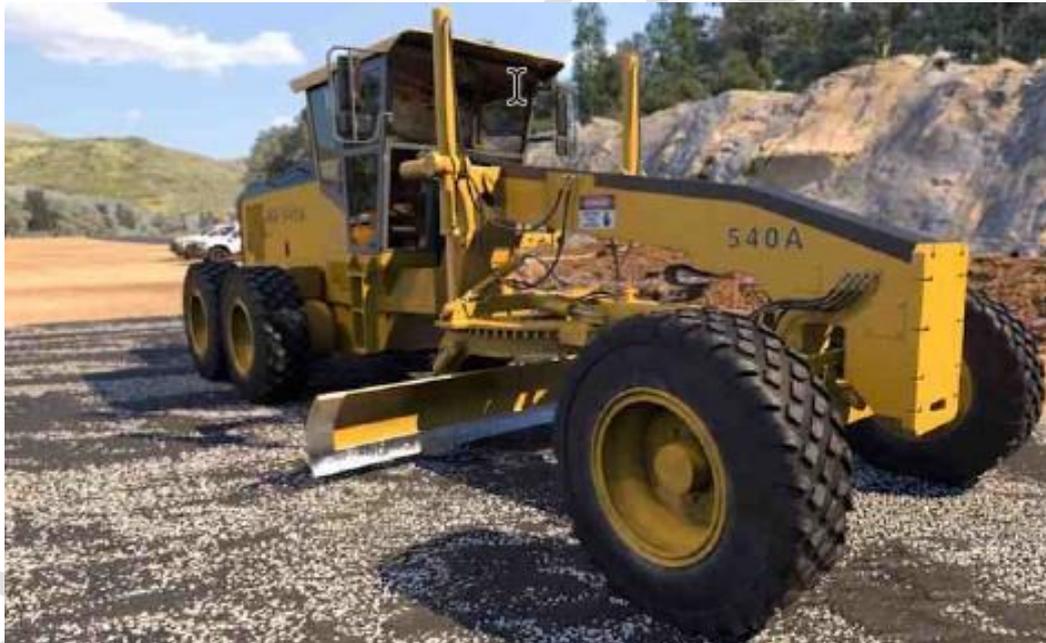
- h) The Grader Operator, employed by ACME Plant Hire, (**Grader Operator**) commenced his assigned work to complete spreading gravel on the southbound carriageway surface by operating a John Deere C68980 Grader. Refer to Figure 1 showing the grader being operated.

Fig. 1: Grader – John Deere C68980

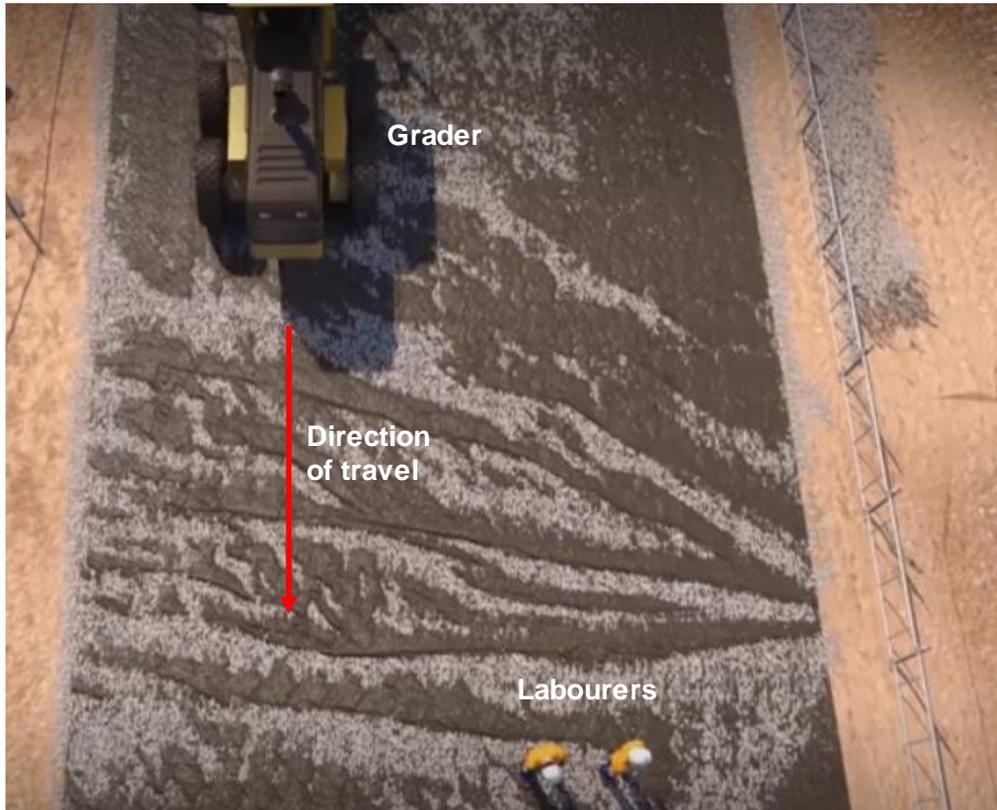
- a) At 1630 hrs both Labourers were working on the Fabric edge preparation facing south with their backs to the grader operating on the carriageway. Labourer #2 spotted the grader “out of the corner of his eye” reversing in their direction. Refer to Figures 2, 3 and 4 showing the location of the labourers in relation to the reversing grader.
- b) Labourer #2 alerted Labourer #1 and they both quickly moved to ensure they were each clear of the grader travel. The Labourers were not in the direct path of the grader; however, were in close proximity; being one to two metres away.

Fig. 2: Aerial view showing direction of travel of the grader and position of the labourers preparing the geotextile fabric on the carriageway.

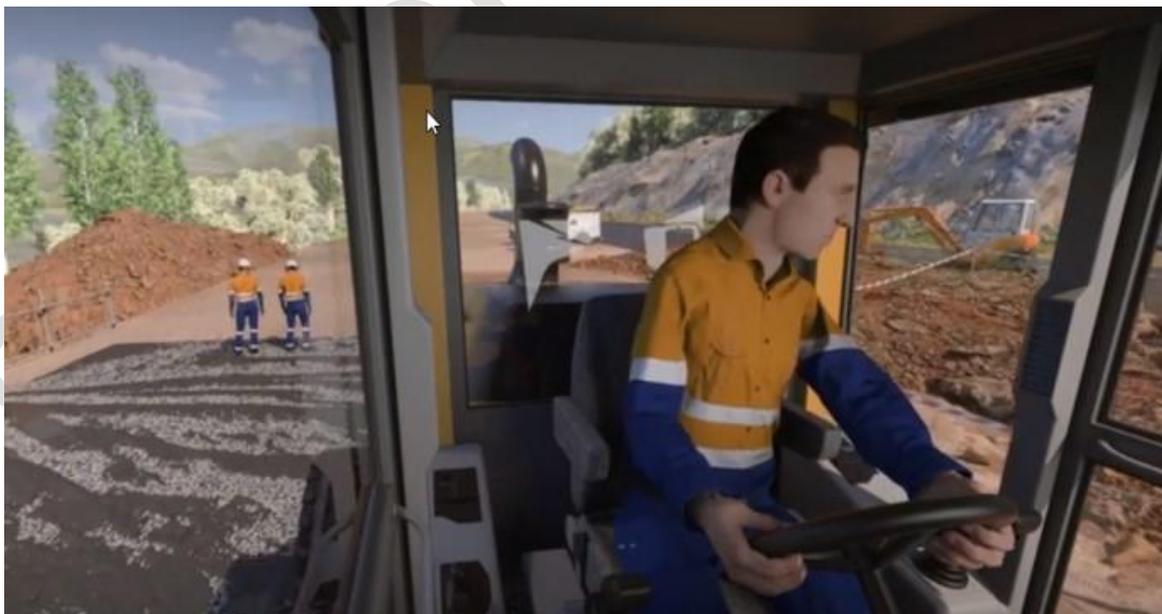
Fig. 3: View from inside the grader showing location of both Labourers.

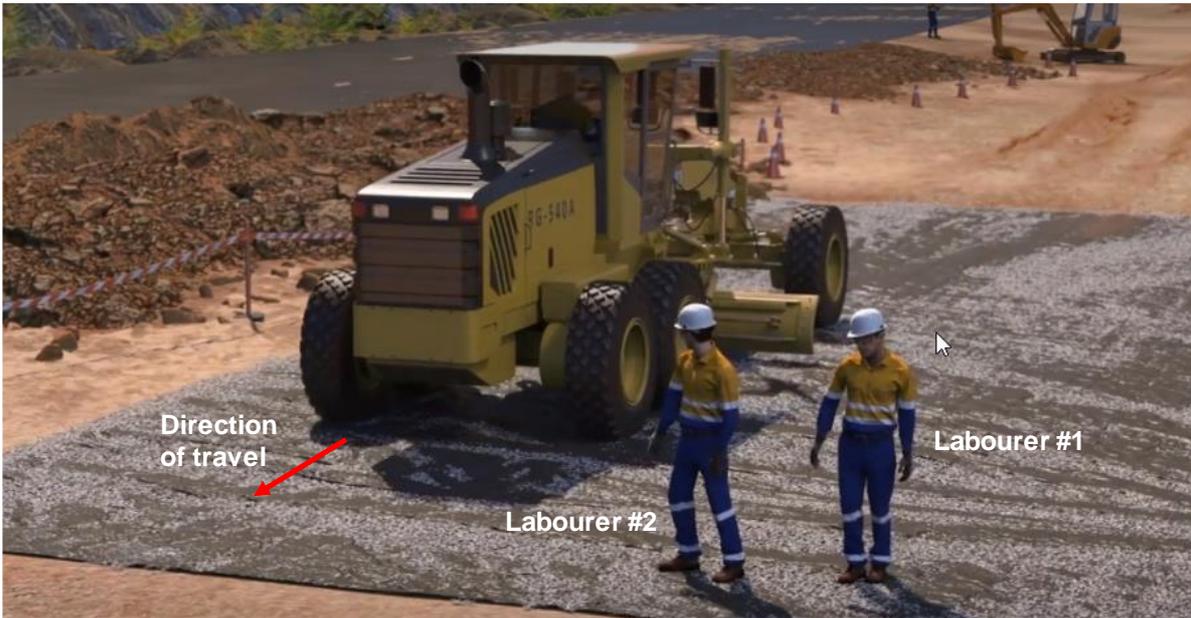
Fig. 4: Location of the grader and Labourers at the time when the Labourers observed the grader reversing in the close proximity to them.

The basic cause of the incident was the failure to ensure adequate separation between the workers installing the Fabric on the carriageway surface and the reversing grader.

All operations involving mobile plant need to be subject to hazard assessment and risk control processes. Separation of mobile plant and pedestrians must be considered and treated as a critical risk to operations.

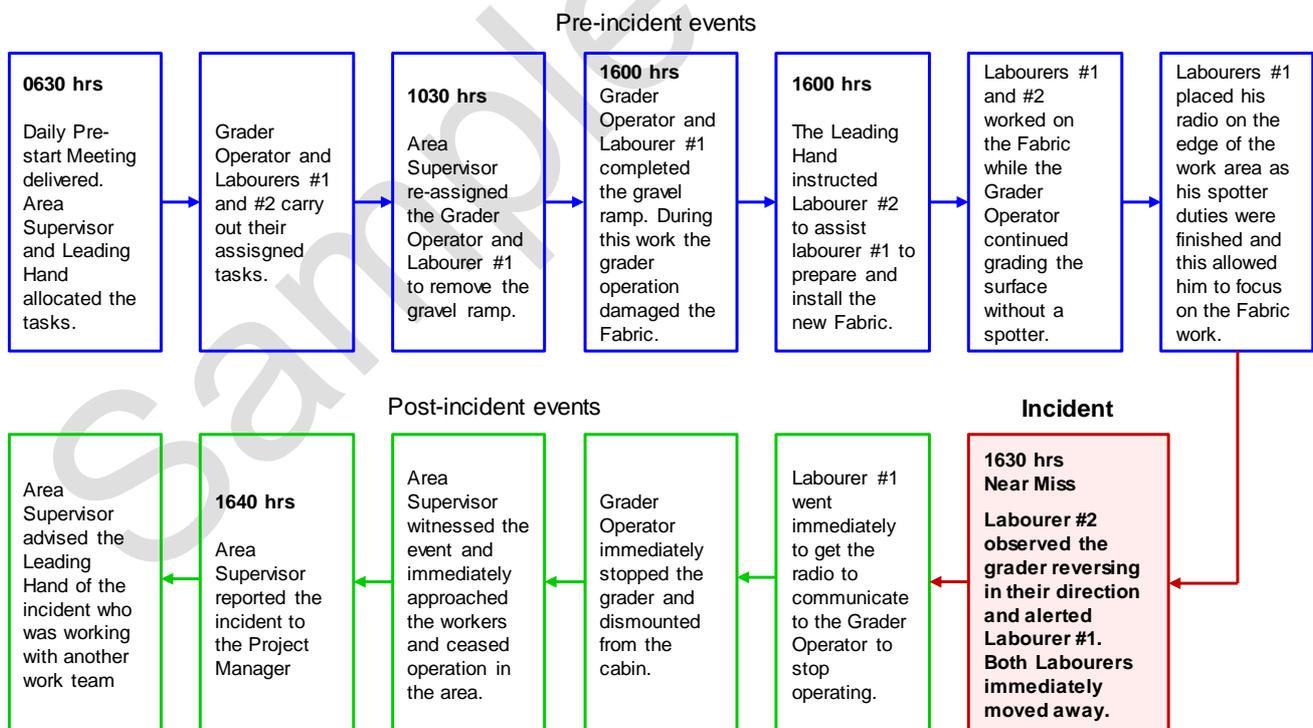
Fig. 5: Time line summary of events
