INCIDENT INVESTIGATION REPORT

UNCONTROLLED RELEASE OF NITROGEN DURING AIRCRAFT MAINTENANCE

Prepared by
Safety Wise Solutions Pty Ltd

SWS 14 Ver 2 (Final) 30 November 2017

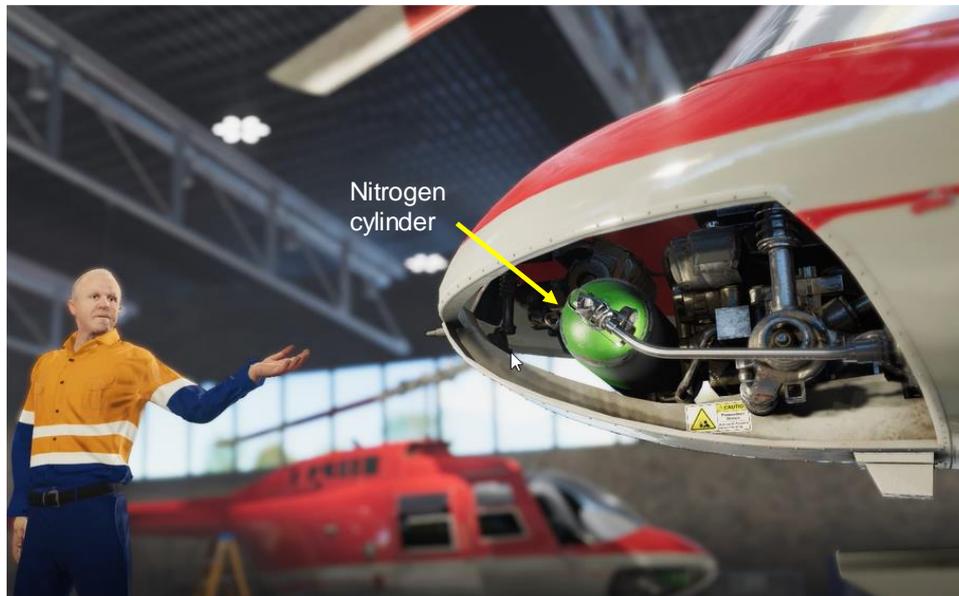
Fig. 1: Bell 412 helicopter, registration VH-BBB, showing the position of the cylinder in the nose section of the aircraft.

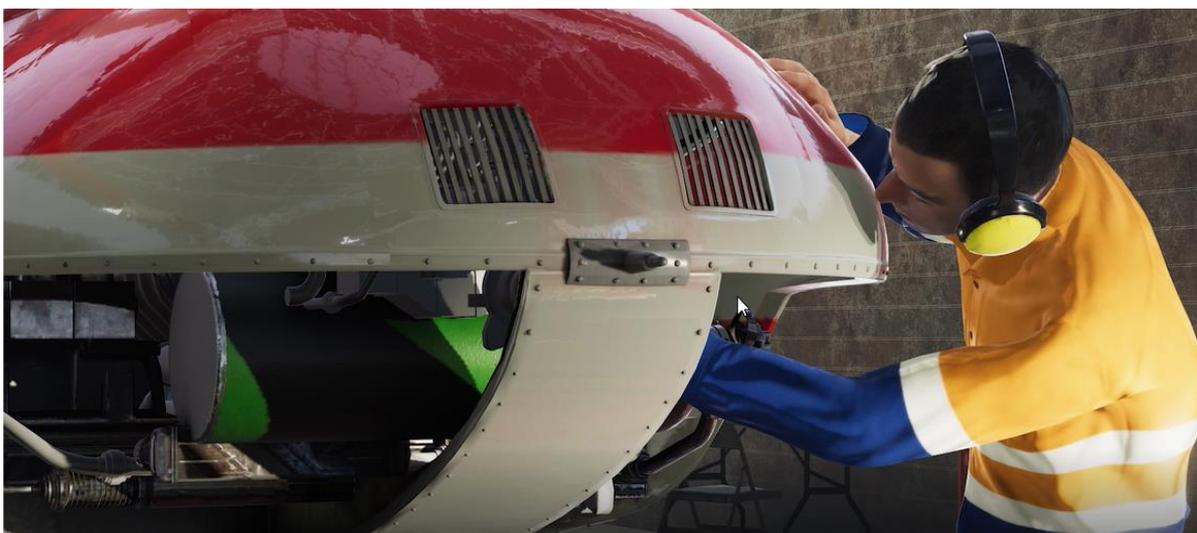
Fig. 2: View showing cylinder in the nose section of the Bell 412 helicopter, registration VH-BBB.

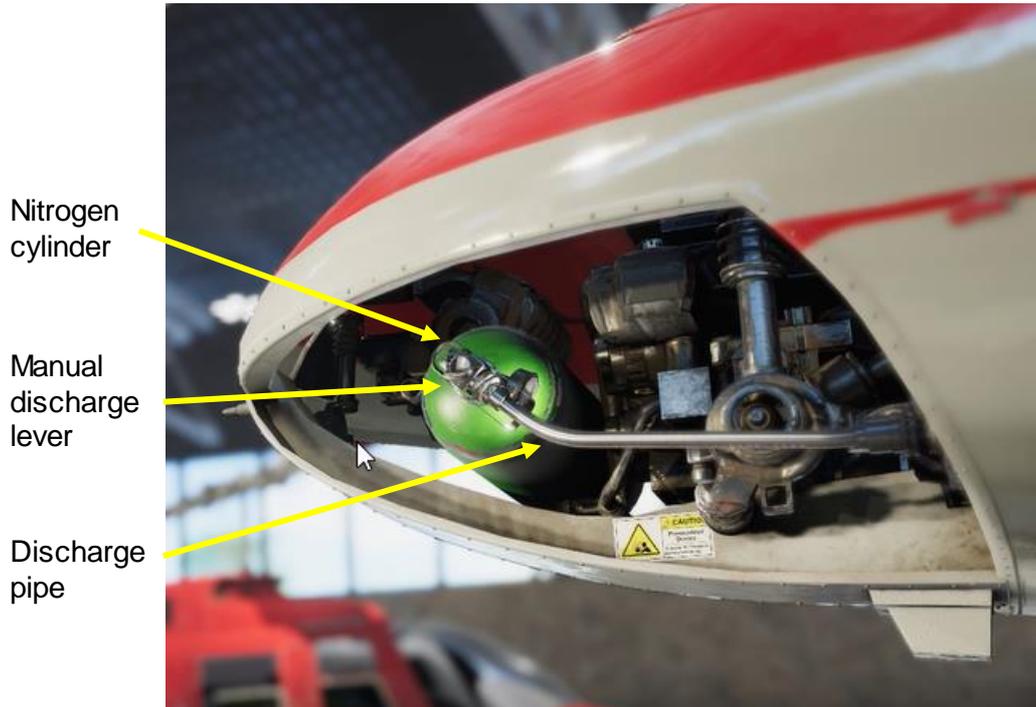
- i) AME#1 removed an electrical box and then disconnected the electrical connector from the cylinder initiating squib. The cylinder restraining straps were released by AME#2 and the stainless-steel discharge pipe was disconnected at the manifold end. The connection at the cylinder was partially loosened, and the discharge pipe was rotated in line with the cylinder, and at 90 degrees to its initial position, to facilitate removal. Refer to Figure 3 showing the cylinder and discharge pipe.

Fig. 3: View showing the cylinder and discharge components in the nose section of the helicopter.

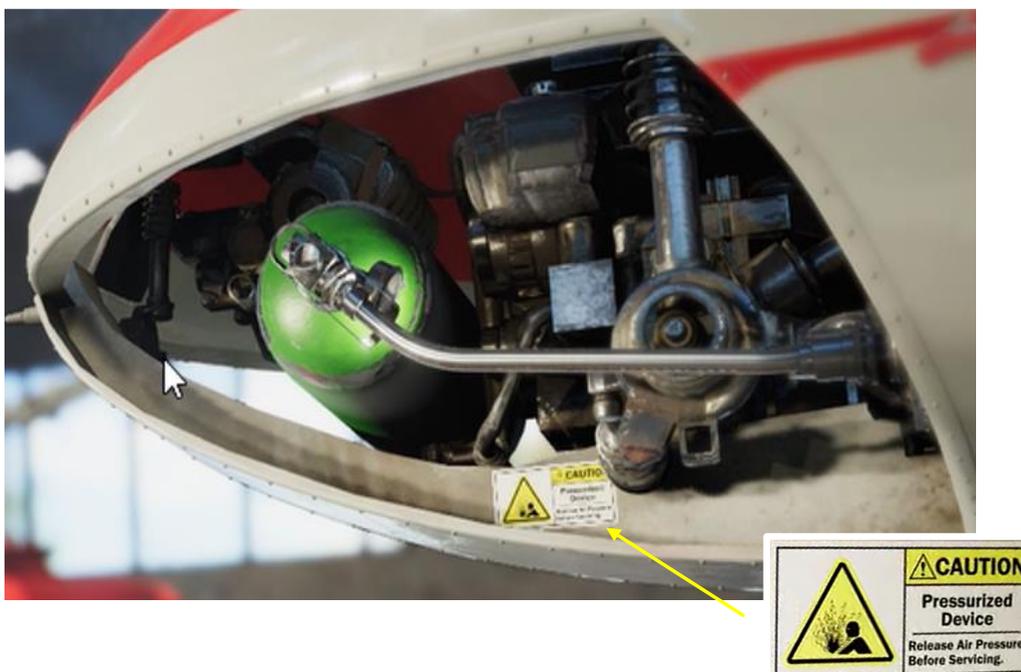
- j) AME#1 then noticed a warning placard and informed AME#2 about the placard (refer to Figure 4) which stated; "release air pressure before servicing." After a discussion between AME#1 and AME#2 about this warning instruction, they both agreed to seek guidance from the Chief Engineer.

Fig. 4: Placard warning and its location in nose section of the helicopter.

- The warning placard, in the nose of the helicopter, was in a position which was not prominent; being away from the cylinder when working around the cylinder. Refer to Figure 4 detailing the placard and its location.
- Time pressure was identified as a perceived pressure incurred by AME#2 to complete the task of discharging the cylinder. This perceived pressure was influenced by the overall working conditions, in the hangar, of the high volume of work and tight timeframes to complete the helicopter maintenance.
- During the manual discharge of nitrogen from the cylinder, AME#2 was in the direct line of the high-pressure uncontrolled release of nitrogen.

- **DE** - Design: The cylinder warning placard information and position was ineffective in providing adequate instructions and warning of the hazard.
- **MC** - Management of Change: There was an ineffective process applied by the maintenance personnel to manage the change in the scope of work for removal of the cylinder.
- **OC** - Organisational Culture: There was management tolerance to 'get the job done' without procedural compliance and/or utilising a robust risk management process prior to carrying out the work.
