INCIDENT INVESTIGATION REPORT into A NEAR MISS BETWEEN A GRADER AND WORK GROUP ON THE COASTAL BYPASS CONSTRUCTION PROJECT

**Prepared by
Safety Wise Solutions Pty Ltd**

SWS 03 Ver 2 (Final) 30 July 2010

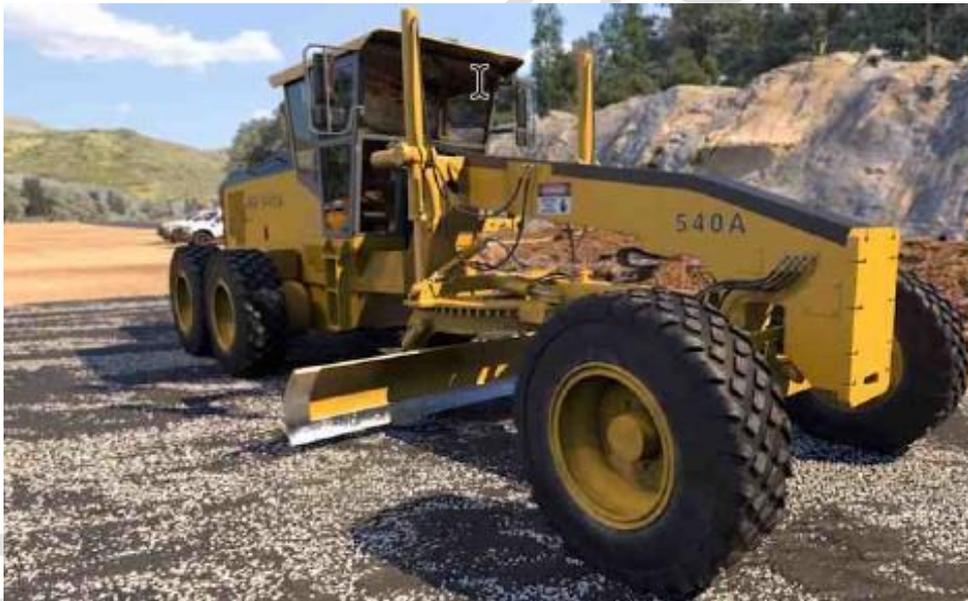
Fig. 1: Grader – John Deere C68980

- h) The Grader Operator, employed by ACME Plant Hire, (**Grader Operator**) commenced his assigned work to complete spreading gravel on the southbound carriageway surface by operating a John Deere C68980 Grader. Refer to Figure 1 showing the grader being operated.

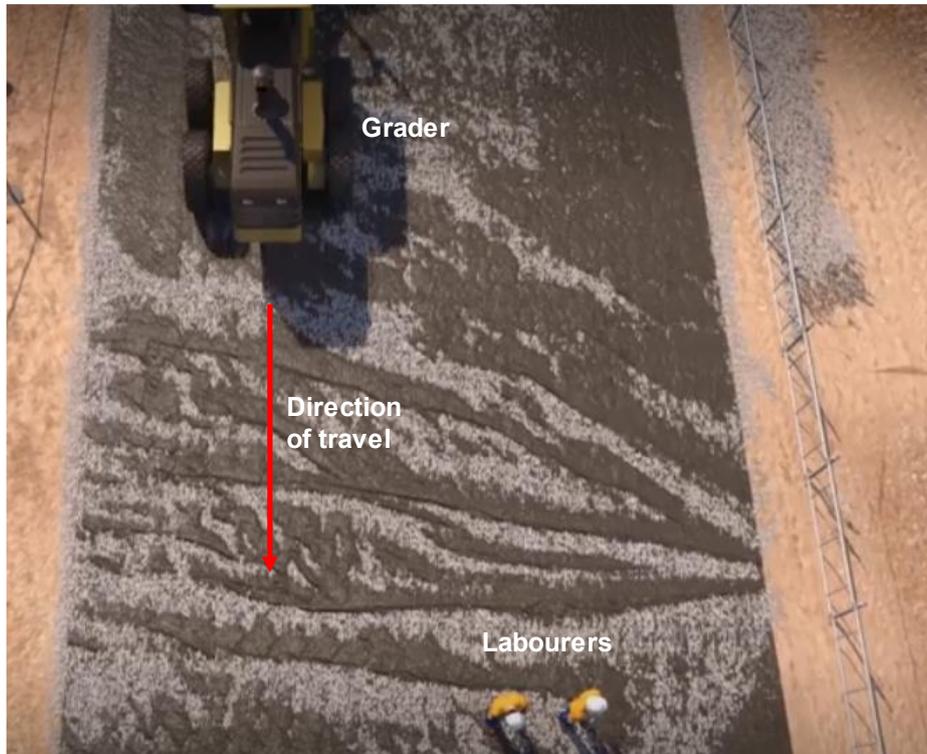
- a) At 1630 hrs both Labourers were working on the Fabric edge preparation facing south with their backs to the grader operating on the carriageway. Labourer #2 spotted the grader “out of the corner of his eye” reversing in their direction. Refer to Figures 2, 3 and 4 showing the location of the labourers in relation to the reversing grader.
- b) Labourer #2 alerted Labourer #1 and they both quickly moved to ensure they were each clear of the grader travel. The Labourers were not in the direct path of the grader; however, were in close proximity; being one to two metres away.

Fig. 2: Aerial view showing direction of travel of the grader and position of the labourers preparing the geotextile fabric on the carriageway.

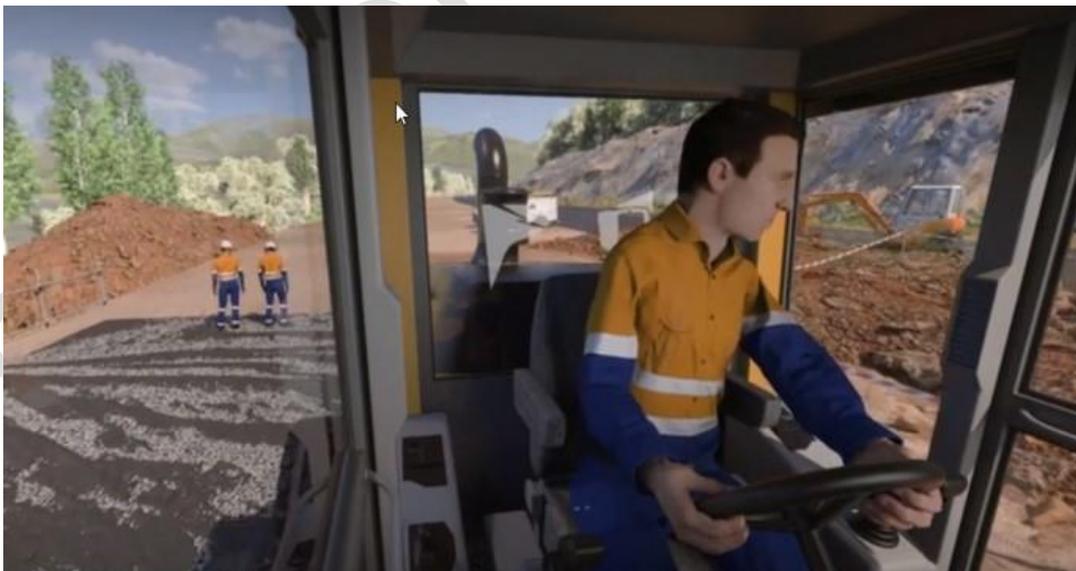
Fig. 3: View from inside the grader showing location of both Labourers.

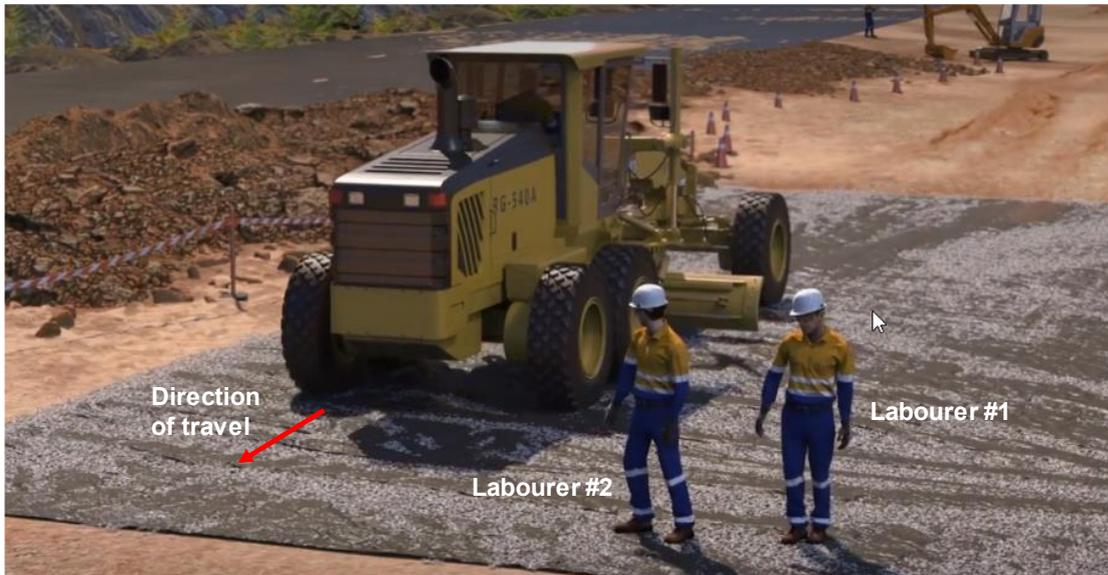
Fig. 4: Location of the grader and Labourers at the time when the Labourers observed the grader reversing in the close proximity to them.

The environmental issue was the unsafe proximity of the two Labourers, only being one to two metres away from the reversing grader operation on the road, without adequate protection and no knowledge of the grader work being performed at the time of the incident.

The basic cause of the incident was the failure to ensure adequate separation between the workers installing the Fabric on the carriageway surface and the reversing grader.

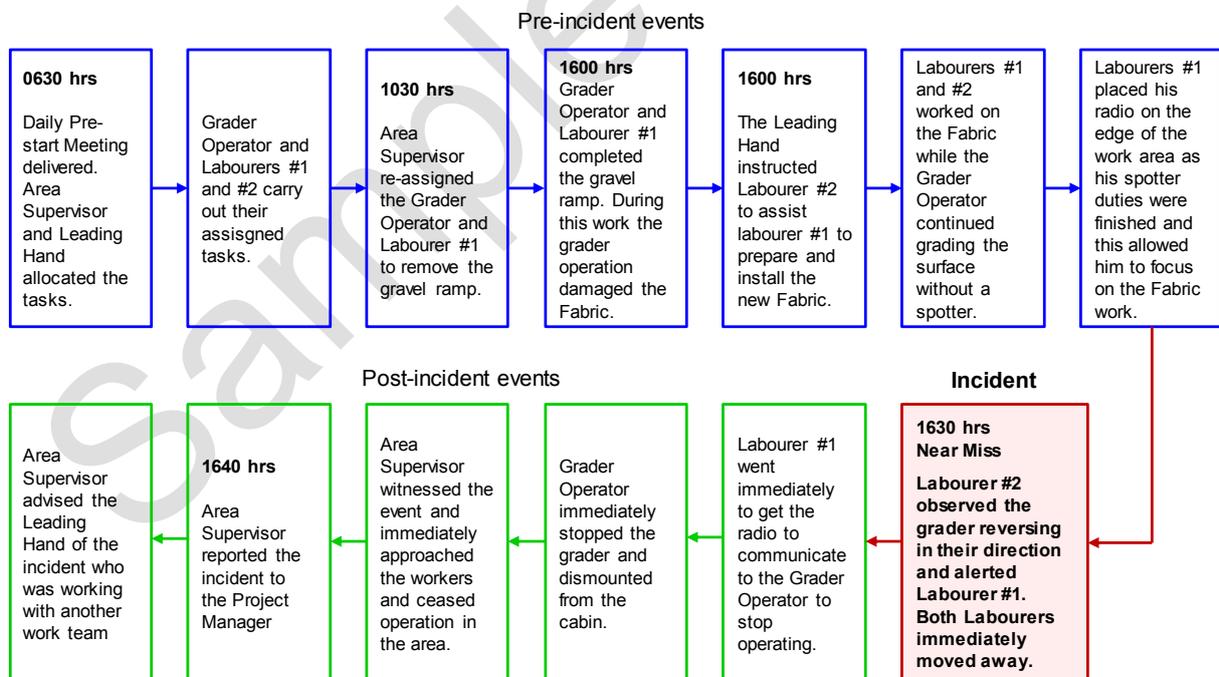
Fig. 5: Time line summary of events
